SOLDERING CONDITIONS

Recommended soldering conditions

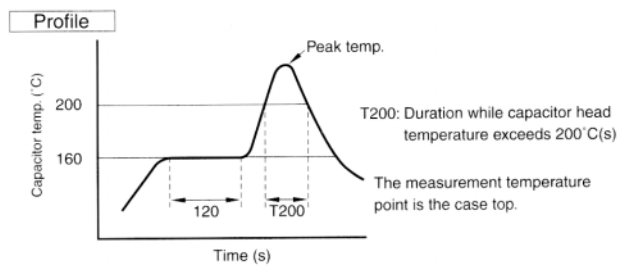
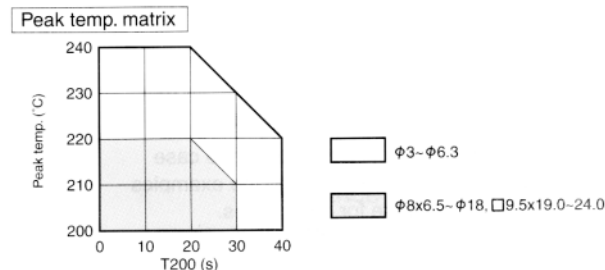
(3) Reflow soldering conditions

1. Preheating shall be under 160 within 120 seconds.
2. Peak temperature shall be within the peak temperature matrix.
3. For conditions exceeding the tolerances, consult with us.

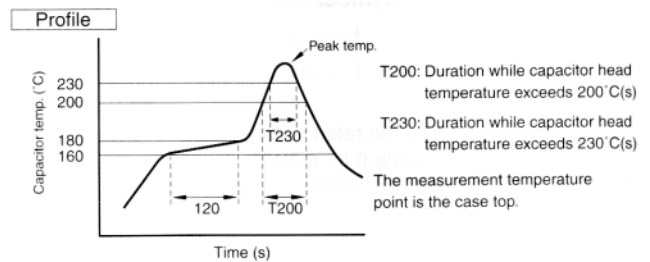
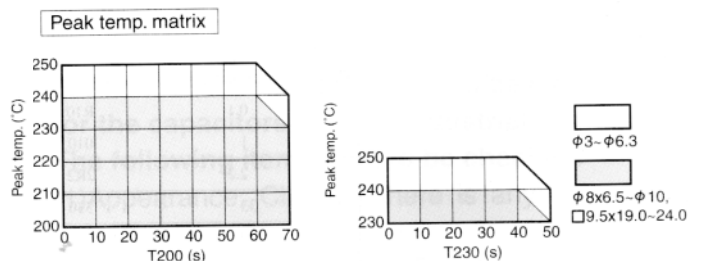
(3) Reflow soldering conditions

1. Preheating shall be under 180 within 120 seconds.
2. Peak temperature shall be within the peak temperature matrix.
3. For conditions exceeding the tolerances, consult with us.

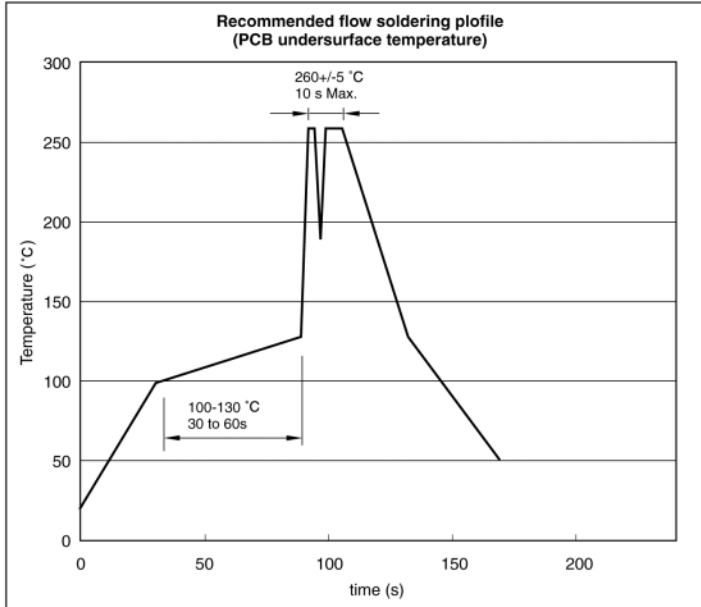
Recommended soldering conditions (Pb-free flow soldering)

The recommendation soldering conditions of the product in which flow soldering is possible are as graph.
